## **Fornaire Service Bulletin No. 109**

**SUBJECT:** Addition of Drain Holes, Concerning all Ercoupes, Aircoupes, and Fornairs Up To Serial No. 5714.

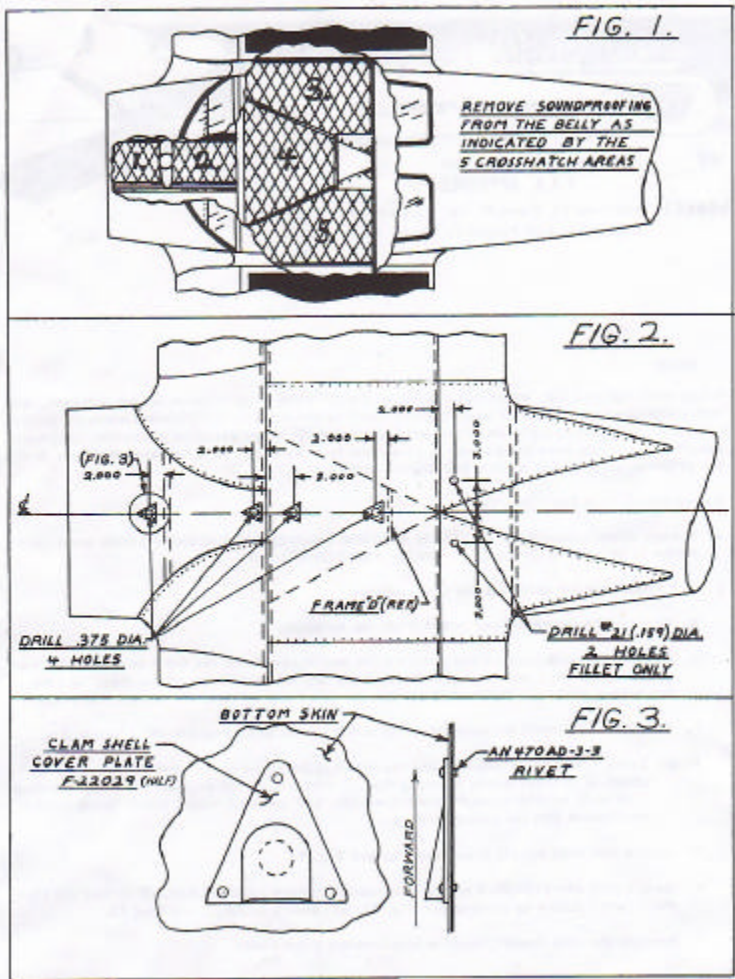
It has been noticed that water can collect in the forward belly regions of the airplane, and that there is no provision for expelling the water to the outside. The trapped water (if acidic) can cause decay and corrosion to the belly structure. Trapped gasoline is another dangerous possibility. Tests have been made to find drain hole locations which will completely drain the problem area for all normal parking attitudes.

- 1 Forney modification kit (FMK) #27 is available which consists of four (4) clam shell cover plates to be used in conjunction with the added drain holes.
- 2 The procedure for modification is as follows:
  - a. Remove the forward floor board from the airplane.
  - b. Remove the seat cushion and unscrew the seat bucket from the front beam (two screws in the center top) and two screws attaching the bucket bottom to the diagonal ribs of the center section. The bucket can now be lifted up, rotating on the rearward hinge.
  - c. Remove (if present) all soundproofing in the lowest belly regions as shown in Fig. 1.

Note: Tests have been conducted and the result of increased noise upon removal of soundproofing in these areas is negligible. Therefore, do not replace the soundproofing. This will enable unobstructed drainage and prevent water from being held by absorption into the soundproofing.
  - d. Locate and drill six (6) drain holes as per Fig. 2.
  - e. Install with AN470AD3-3 rivets (alternative cherry rivets #CR163-4-3) four (4) clam shell cover plates as located per Fig. 2, and shown in detail per Fig. 3.
  - f. Replace the seat bucket, cushion, and forward floor board.
