SERVICE BULLETIN NO. 31 WING CENTER SECTION INSPECTION

REVISION 1

DATE: June 14, 2002

SUBJECT: Visual inspection of wing center section structure for evidence of corrosion and/or damage.

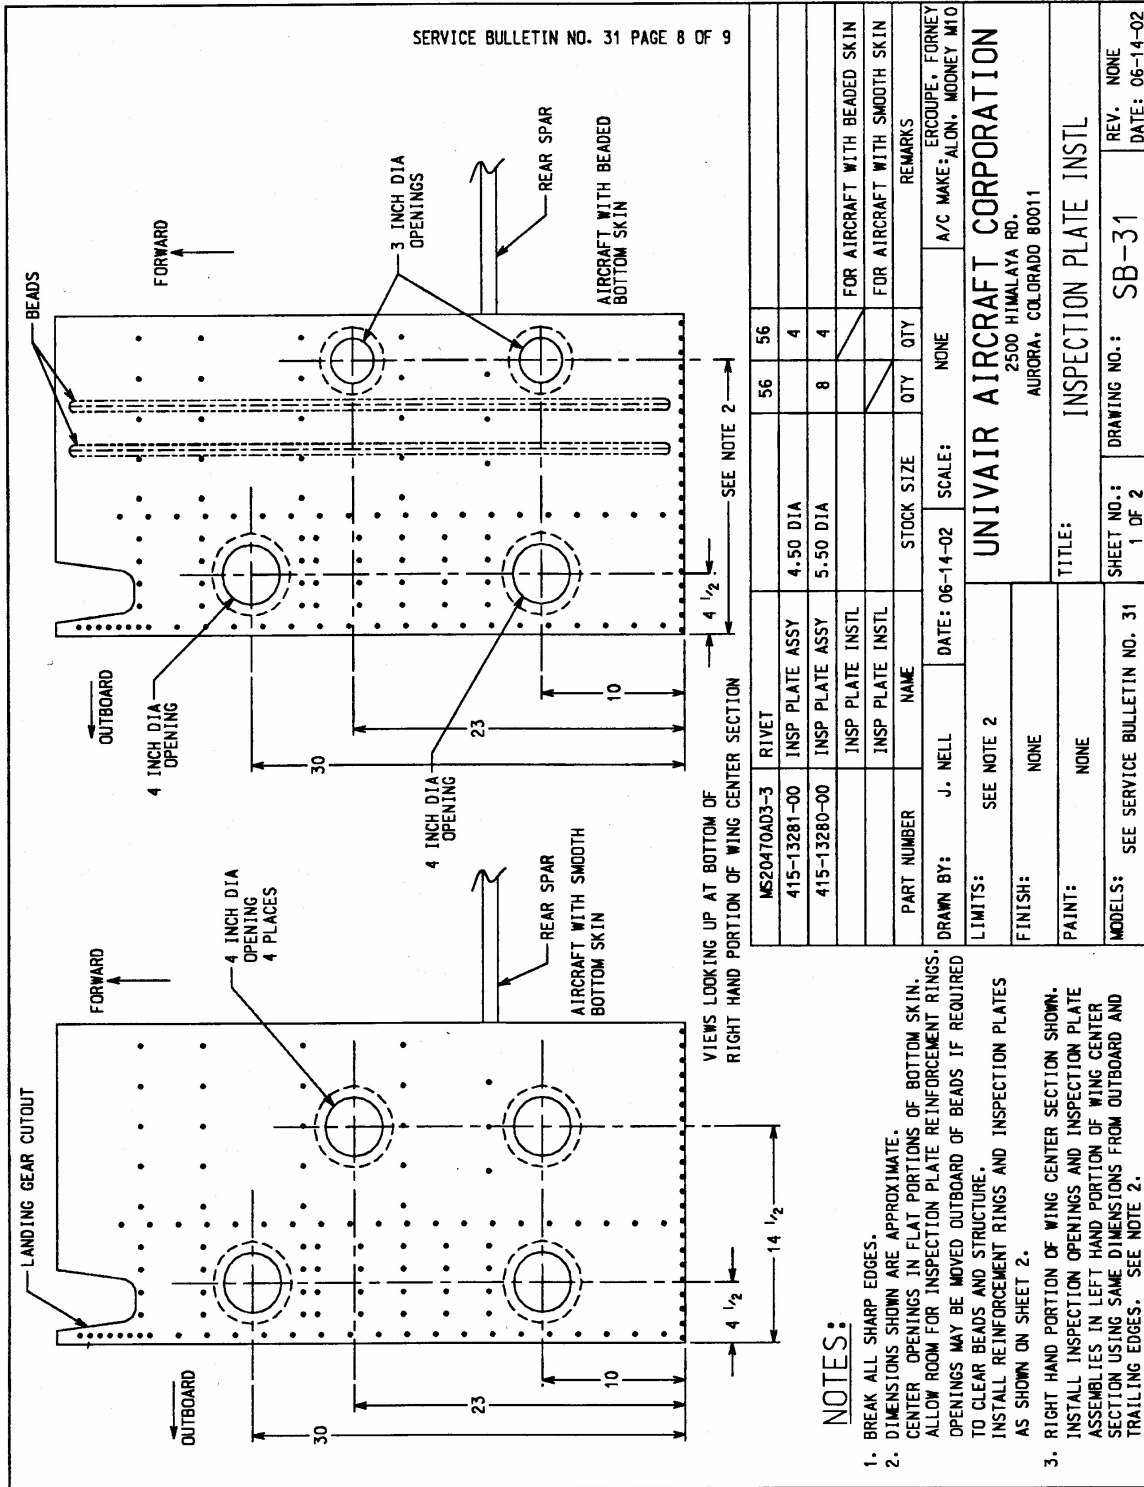
For Method 1: Locate eight inspection openings on the lower wing surface per the enclosed drawing, SB-31, Sheet 1, Revision None, dated 01-29-02. For aircraft with smooth bottom skins, all openings should be 4 inches in diameter. For aircraft with beaded bottom skins, four of the openings should be 4 inches in diameter and four of the openings should be 3 inches in diameter as shown on drawing SB-31.

CAUTION: If the opening locations specified by the diagram interfere with any skin stiffeners, alter the opening location to clear the stiffener. Be sure also to provide clearance for installation of reinforcement rings to be installed in Step 11.

Cut inspection openings at the locations noted above and deburr.
